# Environmental Exposure Report

## Depleted Uranium in the Gulf

Bernard Rostker  
Special Assistant for Gulf War Illnesses  
Department of Defense

Last Update: July 31, 1998

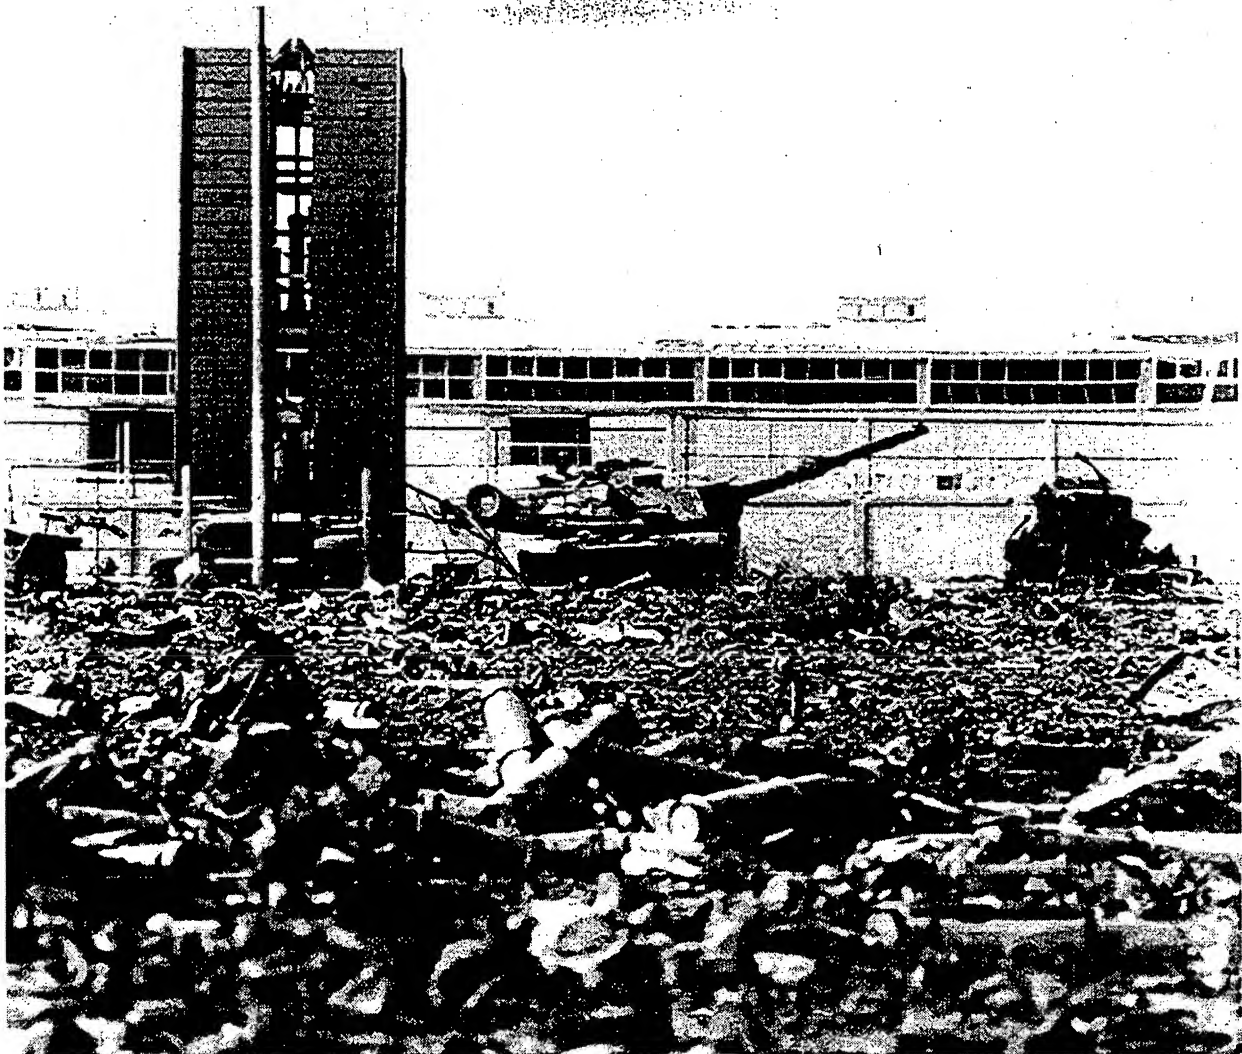
Figure 29 - Aftermath of Doha motor pool fire (view of washrack area) showing armor hulks and UXOs.

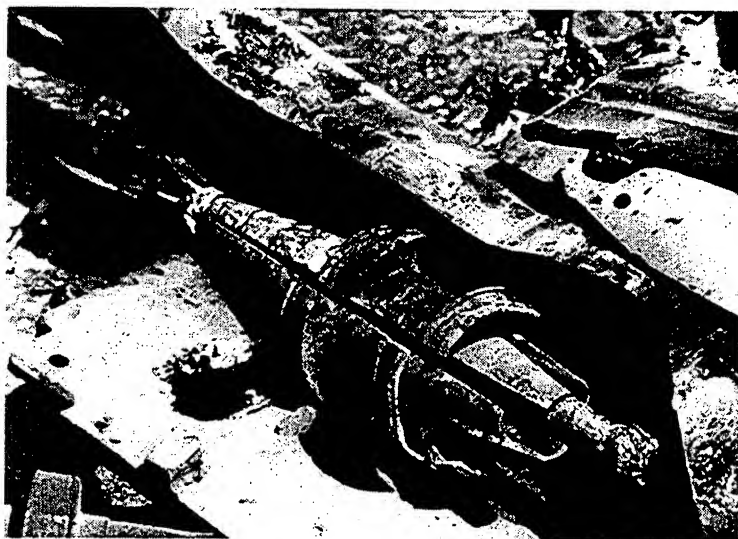
Figure 30 - Burned DU rod and sabot

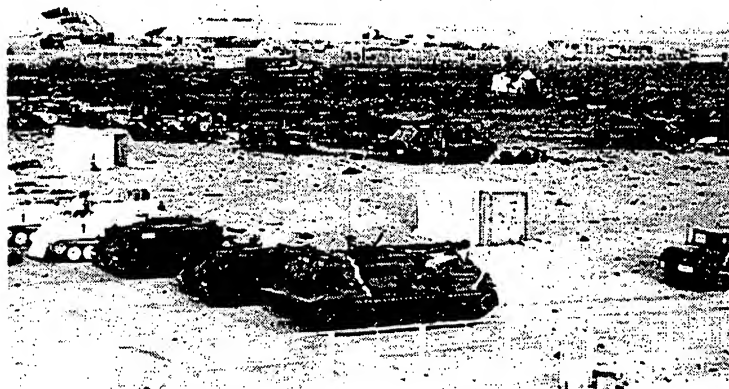
Figure 31 – Aftermath of Doha motor pool fire

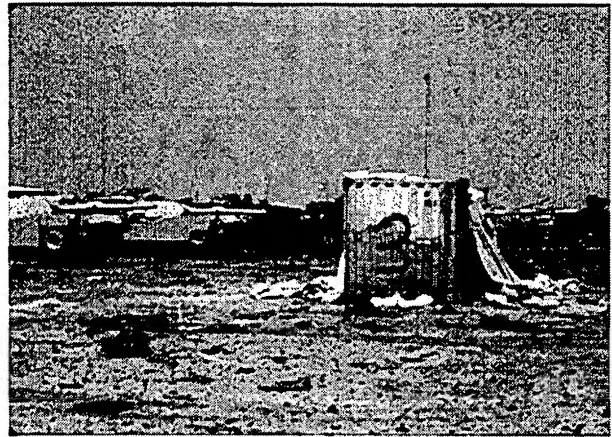
Post-blast photos show many intact conexes among the burned-out wreckage (figure 34). The commander of the 146th Ordnance Detachment (EOD) stated that stored ammunition is more stable than is generally believed, and is fairly survivable except when directly exposed to fires, extreme heat, or explosions. Even in the conexes that blew up, typically only a few shells would detonate, scattering the other rounds rather than touching off a massive "sympathetic" detonation. This explains the huge quantity of unexploded ordnance (UXOs) littering the motor pool area.<sup>223</sup> Large numbers of the lightweight

Figure 34 - Surviving Munitions Conex

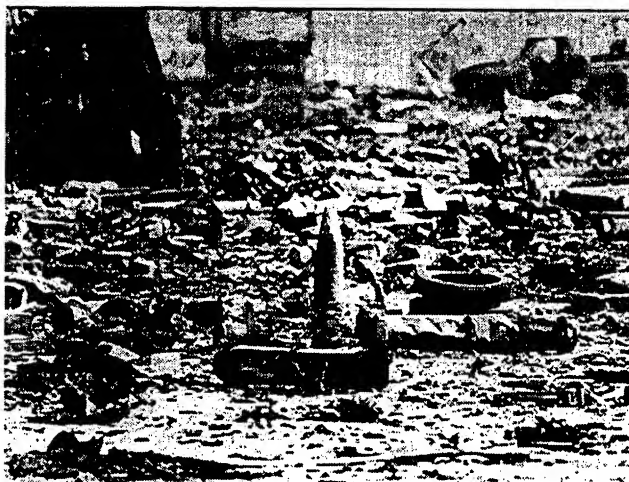
EOD members viewed the staggering quantities of UXOs they had to contend with as the most grave and immediate threat at Doha. By its nature, explosive ordnance disposal is an extremely dangerous undertaking, and the sheer magnitude of the task facing the 146<sup>th</sup> Ord Det. at Doha cannot be overstated. These hazards were tragically underscored on July 23, twelve days after the initial blast and fires. Two senior EOD non-commissioned officers and a 58<sup>th</sup> CEC soldier died instantly in an accidental UXO blast. The fatal mishap had a significant impact on the remainder of the cleanup effort, and, particularly, on the 146<sup>th</sup> Ordnance Detachment.

Figure 36 - UXOs in Doha's North Compound

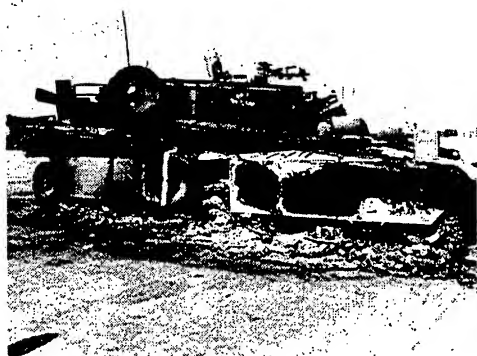
All four of the M1A1s were damaged/destroyed as a result of fires external to the vehicle. *There were no penetrations anywhere of the exterior armor* (emphasis added). Three of the four M1A1s had their fuel and ammunition destroyed. In these three cases, there was an explosion in the ammunition compartment. The ammunition doors and blowout panels functioned properly, keeping the blast from entering the crew compartment. The fourth M1A1 was damaged on the right suspension only, and except for the gunner's computer and transmission warning lights, was completely operational.<sup>251</sup>

Figure 40 - Burned-out Doha M1A1

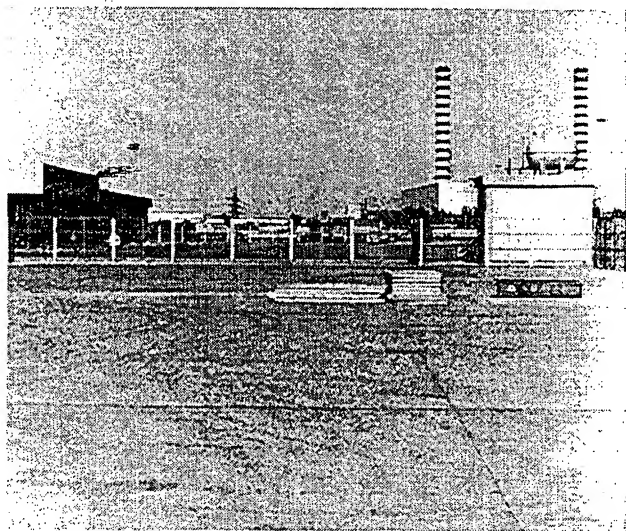
Figure 43 - Doha motor pool pad after cleanup

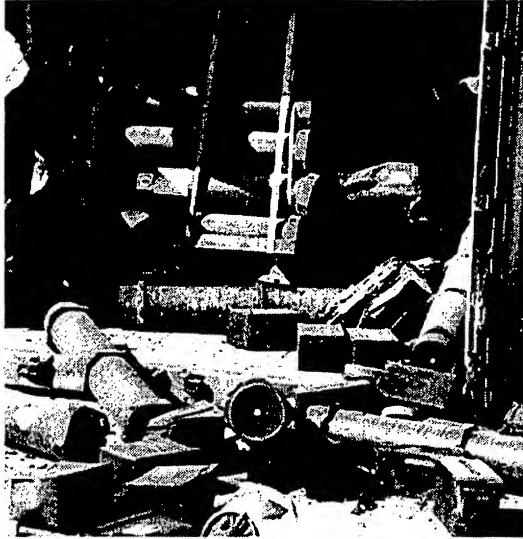
Figure 44 - Unexploded DU rounds
